SUSQUEHANNA RIVER BASIN  
NANTICOKE CREEK WATERSHED PROJECT  
SITE 8  
BROOME COUNTY, NEW YORK  
INVENTORY NO. NY 573

PHASE I INSPECTION REPORT  
NATIONAL DAM SAFETY PROGRAM

SUSQUEHANNA RIVER BASIN  
NANTICOKE CREEK WATERSHED PROTECTION  
PROJECT SITE No. 8  
I.D. No. NY-573 (# 85D-3645)  
PHASE 1 INSPECTION REPORT

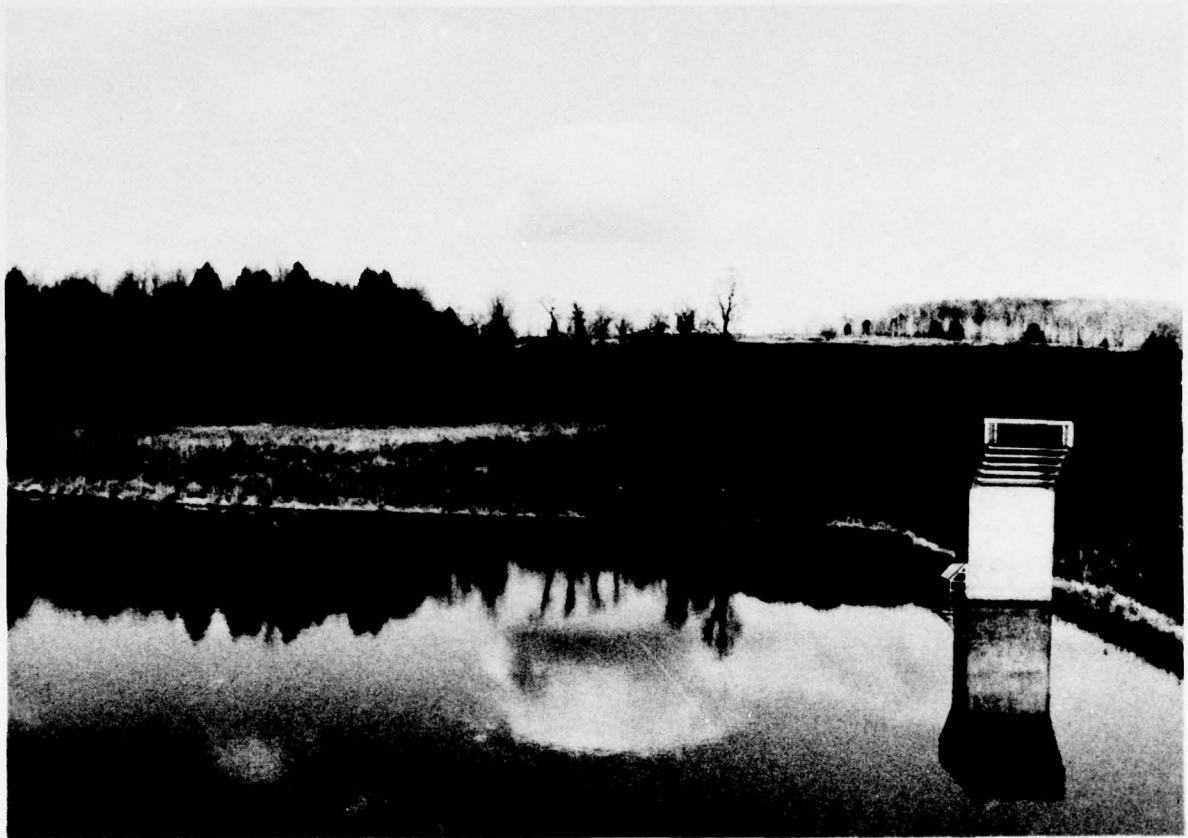
NANTICOKE CREEK SITE No. 8 OVERVIEW  
NORTHERN END OF UPSTREAM FACE AND EMERGENCY SPILLWAY

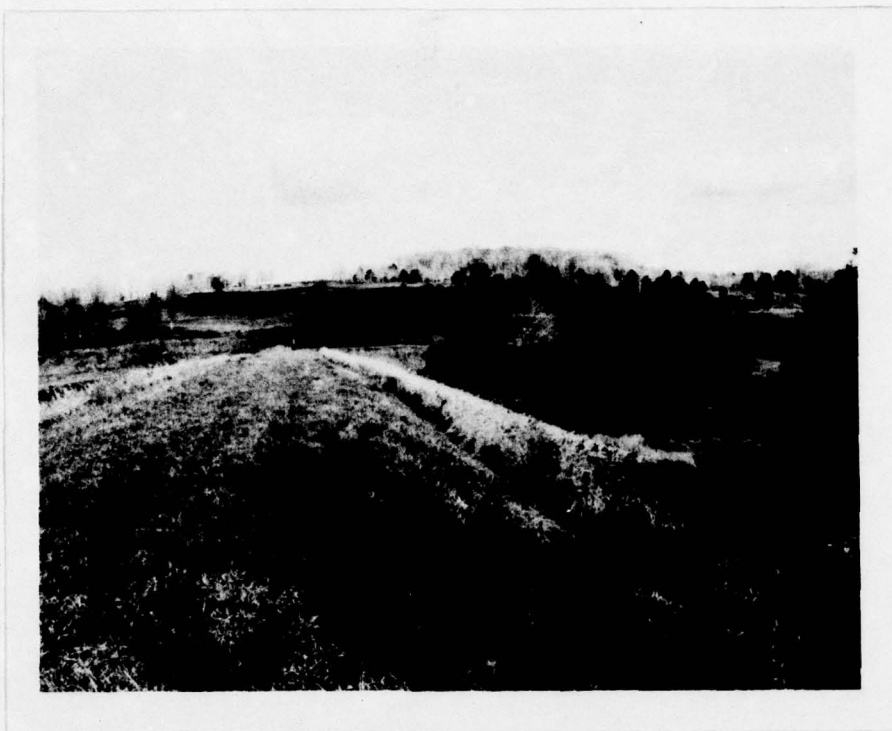
No undesirable vegetative growth or animal penetrations into the slopes were observed. However, on the date of the inspection, the grass on the upstream and downstream slope had not been mowed.

VIEW LOOKING EAST ALONG DAM CREST

To assure the continued satisfactory performance of this structure, a schedule of periodic maintenance should be established. Included in this schedule should be items such as mowing the grass on the embankment slopes and periodic operation and lubrication of the slide gate mechanism.

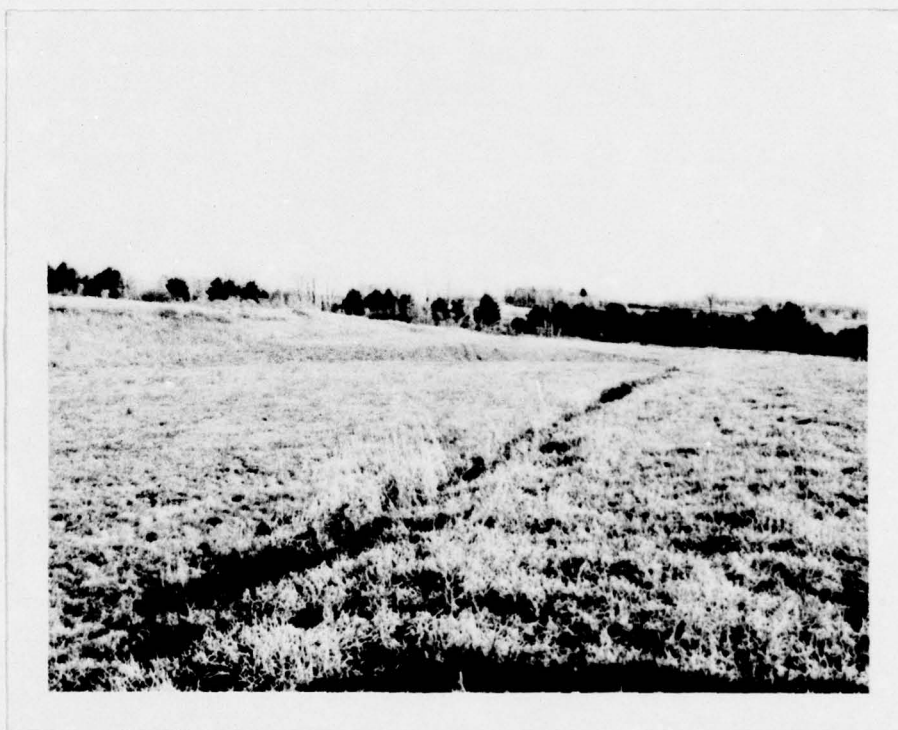
A grass lined emergency spillway in an earth cut section is located beyond the northern end of the embankment. The spillway had been mowed and appeared to be in satisfactory condition.

EMERGENCY SPILLWAY LOOKING DOWNSTREAM

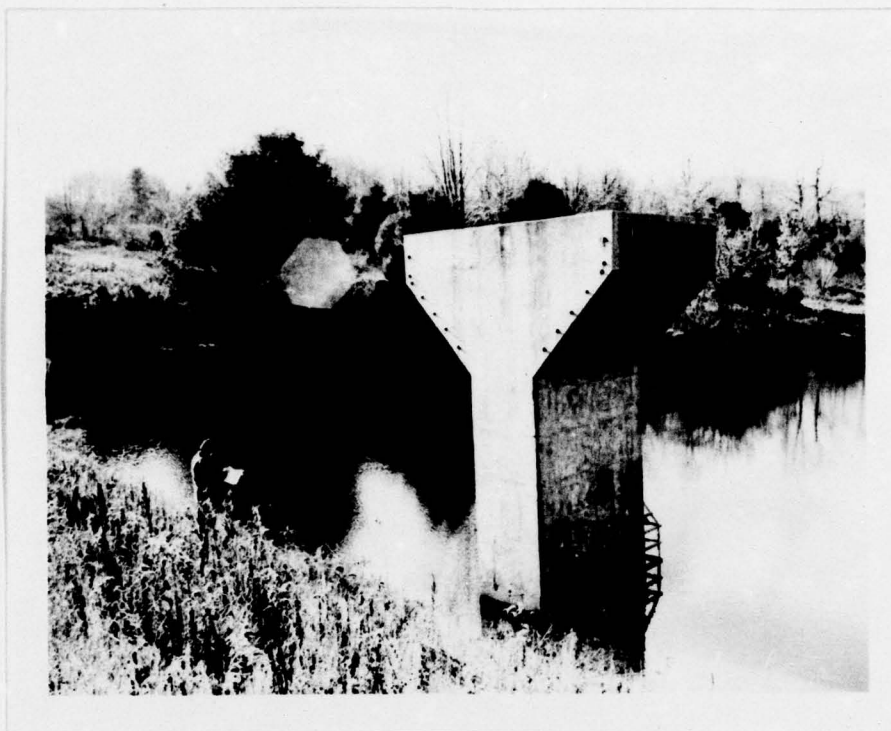
RISER - PRINCIPAL SPILLWAY INLET

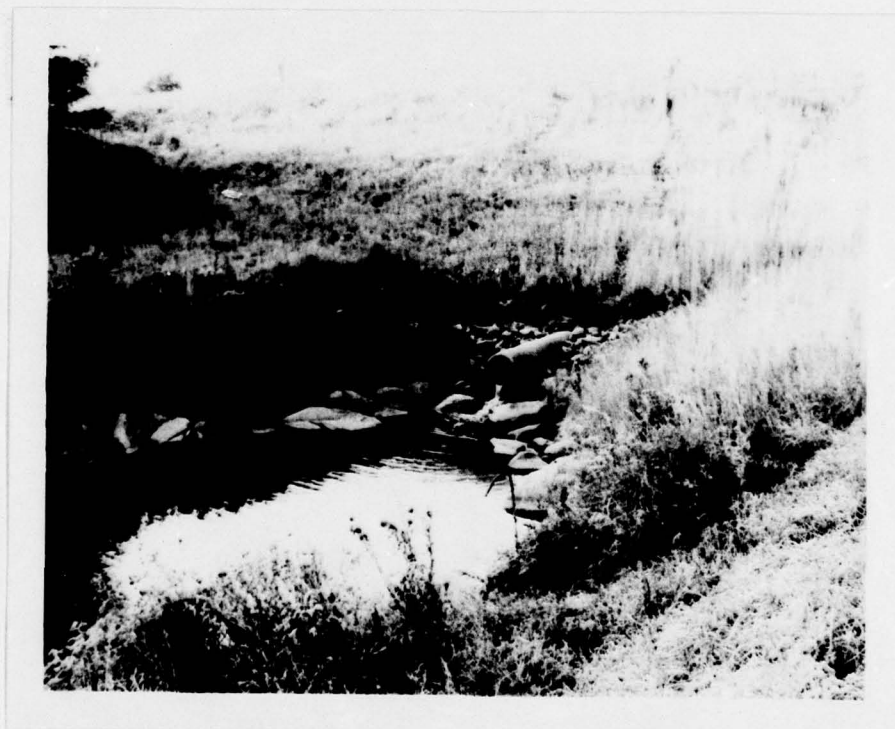
The principle spillway consists of the vertical drop inlet structure, a reinforced concrete pressure pipe through the embankment, a plunge pool and an outlet channel. All of these components were in satisfactory condition. The only minor deficiency noted concerned the plunge pool. The downstream toe of the dam, the bottom of the stream channel and the stream banks were lined with riprap, but there was no riprap in the center of the stream to check the velocity of water coming through the spillway pipe.

PRINCIPAL SPILLWAY OUTLET PIPE  
AND PLUNGE POOL (LOOKING UPSTREAM)

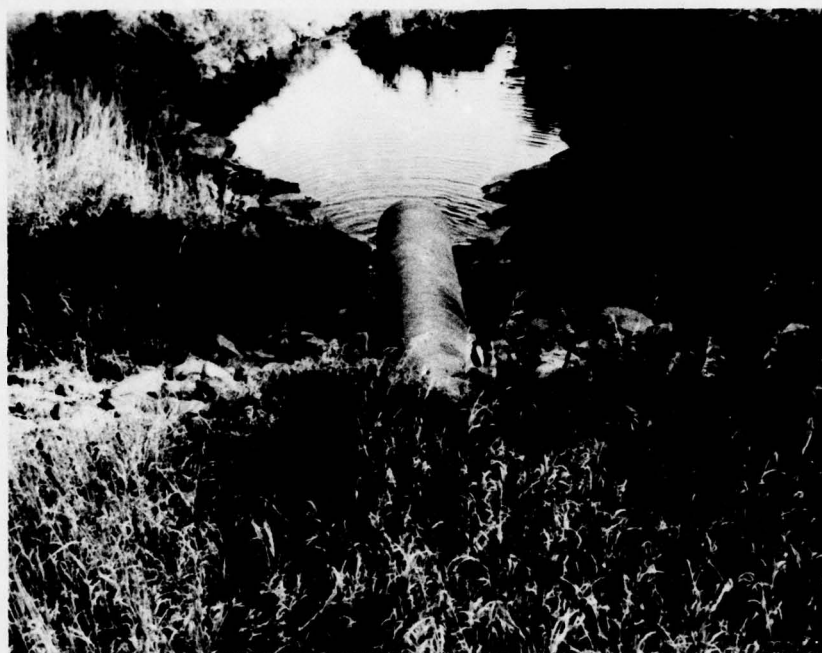
PRINCIPAL SPILLWAY OUTLET PIPE  
AND PLUNGE POOL (LOOKING DOWNSTREAM)

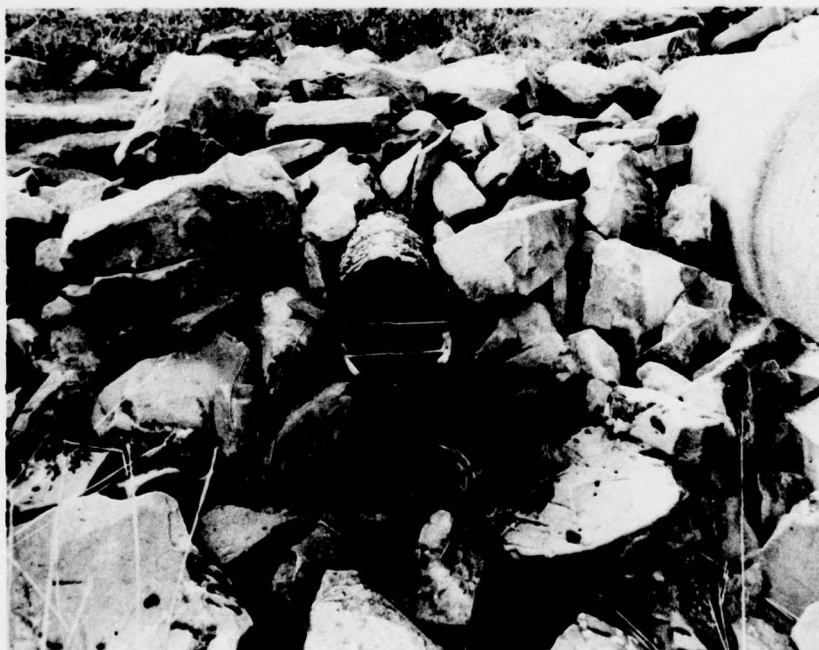
OUTLET OF INTERNAL DRAINAGE  
SYSTEM COLLECTION PIPE
